The Effects of Roots Action of Tropical Green Roofs—Replication of German FLL in Singapore

Kian. Kai. Tan, Michael. Yit. Lin. Chew, Nyuk. Hien. Wong

Abstract—Green Roofs offers numerous advantages, including lowering ambient temperature, which is of increasing interest due to global warming concerns. However, there are technical problems pertaining to waterproofing to be resolved. Currently, the only recognized green roof waterproofing test is the German standard FLL. This paper examines the potential of replicating the test in tropical climate and reducing the test duration by using pre-grown plants. A three year old sample and a new setup were used for this experimental study. The new setup was prepared with close reference to the FLL standards and was compared against the three year old sample. Results showed that the waterproofing membrane was damaged by plant roots in both setups. Joints integrity was also challenged.

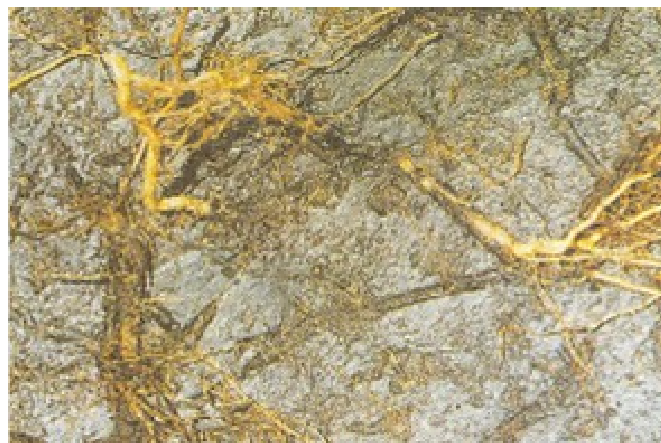
Fig. 1 Roots leaving impression on waterproofing membrane, adapted [10]

However, due to the nature of the construction industry and the scale of building projects, it is almost impossible for a building to be defect free, including green roofs. Defect on green roof waterproofing membranes are reported in [10], as shown in fig. 1.

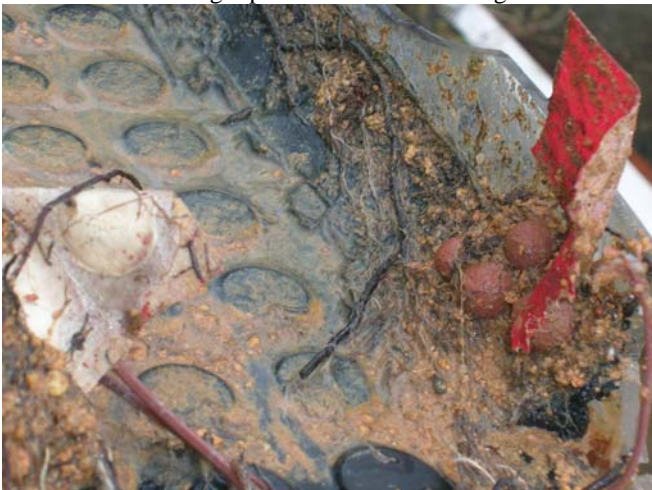
Fig. 6 Roots seemed to have grown into the liquid applied waterproofing at the edge

Roots did not grow into the membrane at this area but did seem to grow into the liquid applied waterproofing material used to seal the edges of the sample box. However, there was no evidence of outright penetration as seen in fig. 6.

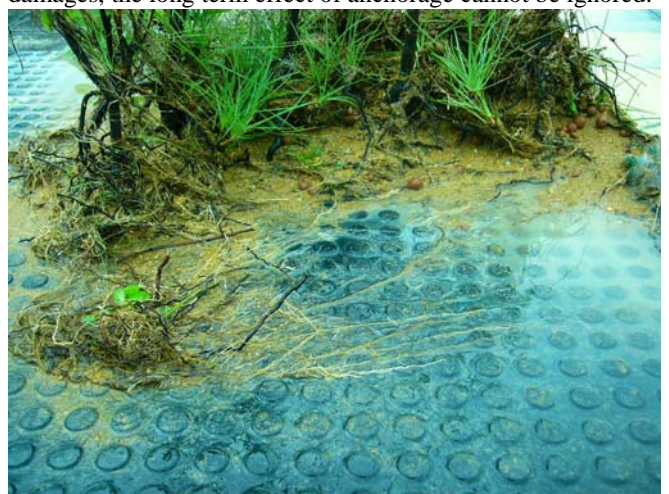
Fig. 8 Roots left on the membrane after some erosion; the plants are removed whereas roots which have anchored on the membrane are cut from the plant

From fig. 8, minor roots which seemed to have anchored on the membrane can be seen. The coverage of these roots was about 40%. Though at closer examination, there was no sign of damages, the long term effect of anchorage cannot be ignored.

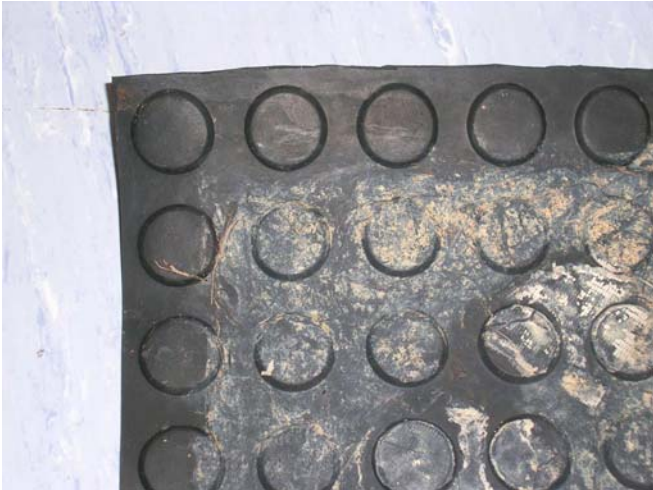
Fig. 9 Clean sheet membrane edges indicate no form of growth between the liquid applied waterproofing and sheet membrane

The liquid applied waterproofing was subsequently detached from the sheet membrane and it revealed that no root grew into the joint (fig. 9).

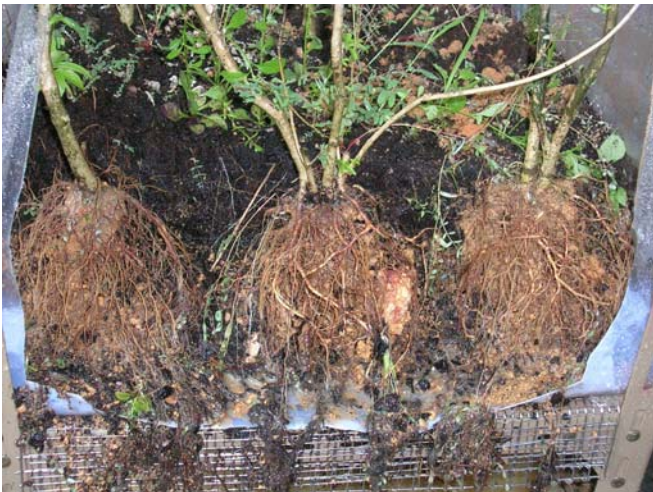
Fig. 10 Vast root structures

Soil was also removed with a water jet. Upon removal of the first 10mm of soil, substantial root structure was noticed. This again signifies extensive root structure. Further erosion of soil revealed that all the root structures were more well established than those in sample 1, indicating that there was good root growth and the artificial environment created for this sample was conducive for root growth. The root coverage was more than 50% throughout, which was more than sample 1 (15-20%), as seen in fig. 10.

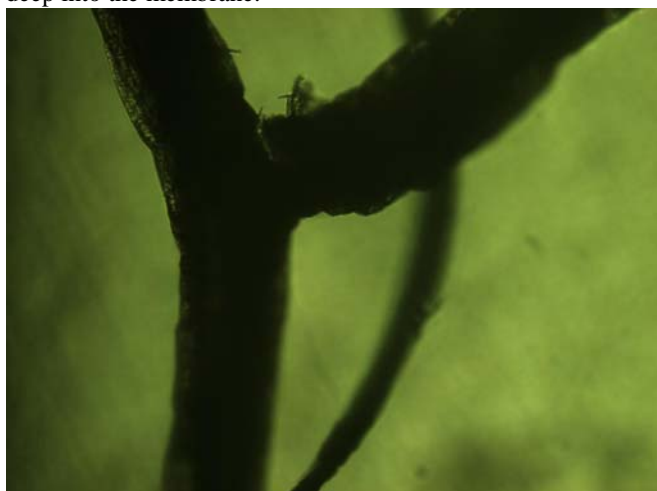
Fig. 14 20× magnification of typical area focusing on the root

Fig. 14 shows an area under magnification, focusing at different heights. The top fig. focuses on the root while the bottom fig. focuses on the membrane. This implies that as there was an inability to focus on both the membrane and the root, there was a substantial difference in the level of the root and the membrane. This indicates that the root has not grown deep into the membrane.
